***In compiling this short history on car number:-***

***UE 1S 25926 BW (Reg No FUE 38M)***

*The Jaguar E Type Series III V12 Roadster, body number 4S 8745 now registered FUE 38M was completed at the Jaguar Coventry Works on 9 May 1974. It was built to meet the American (Federal) car/road vehicle specification in force at that time.*

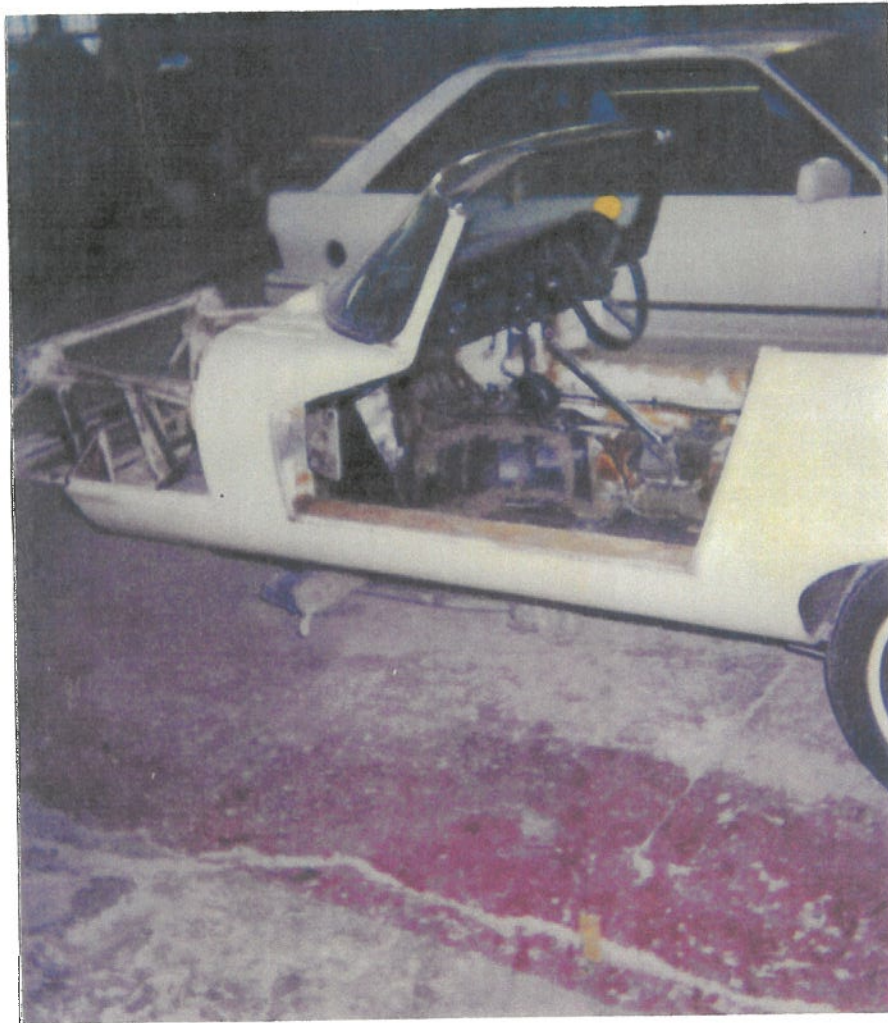
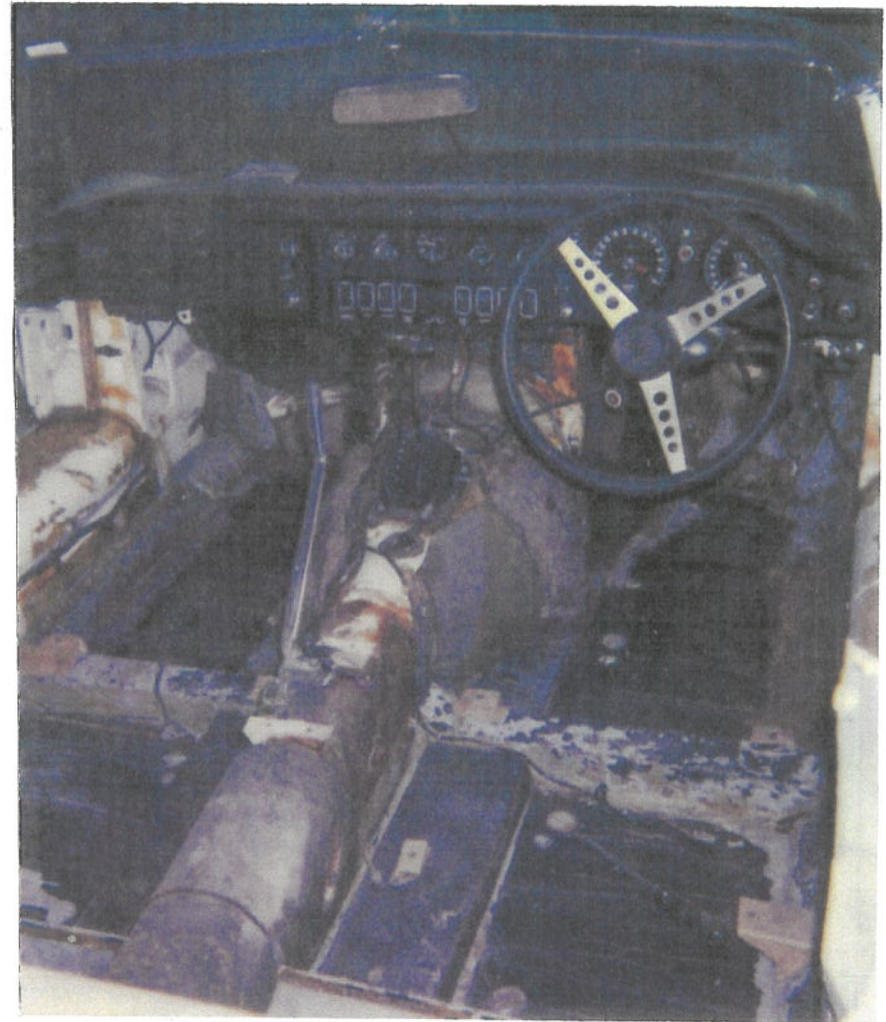
Photographs 7 and 8 – Car in process of being stripped

*On completion of the static and running checks the next 10 months, April 1990 to early 1991, were spent stripping the car of every component (Refer Photographs 7 and 8). The monocoque frame was specialist cleaned, (Refer Photograph 9) any damage repaired, (Refer Photograph 10) undercoated and sprayed, (Refer Photograph 11) as were doors, boot lid and bonnet (Refer Photograph 12).*

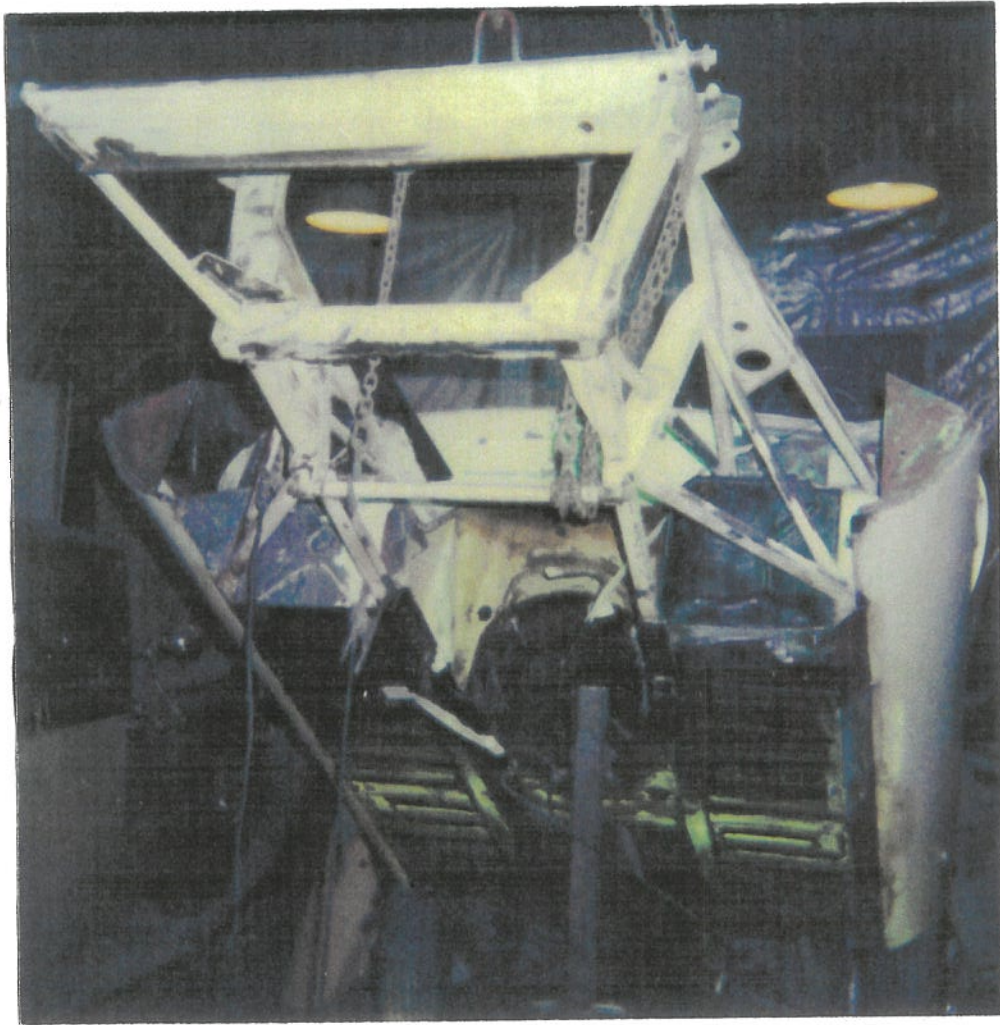
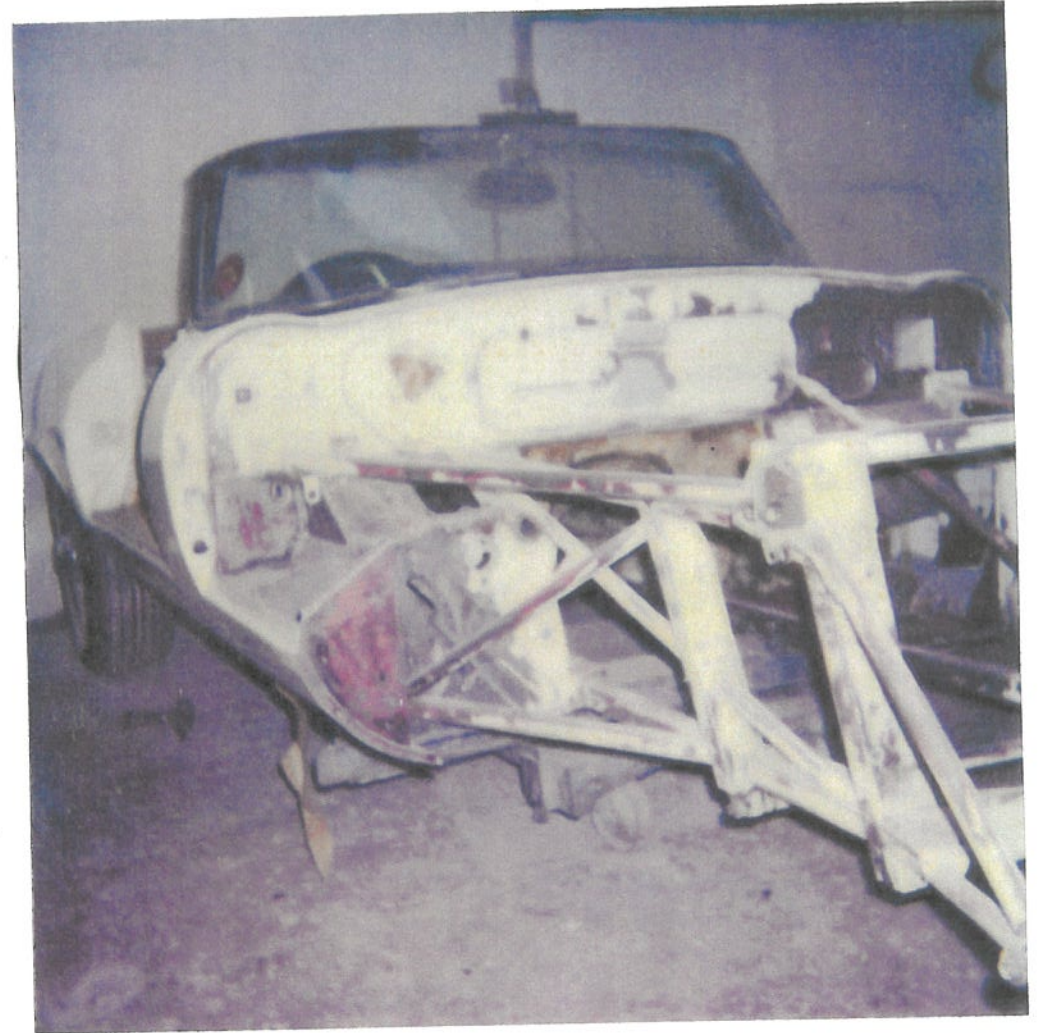
Photographs 9 and 10 – Chassi almost and completely stripped, hoisted for any repairs

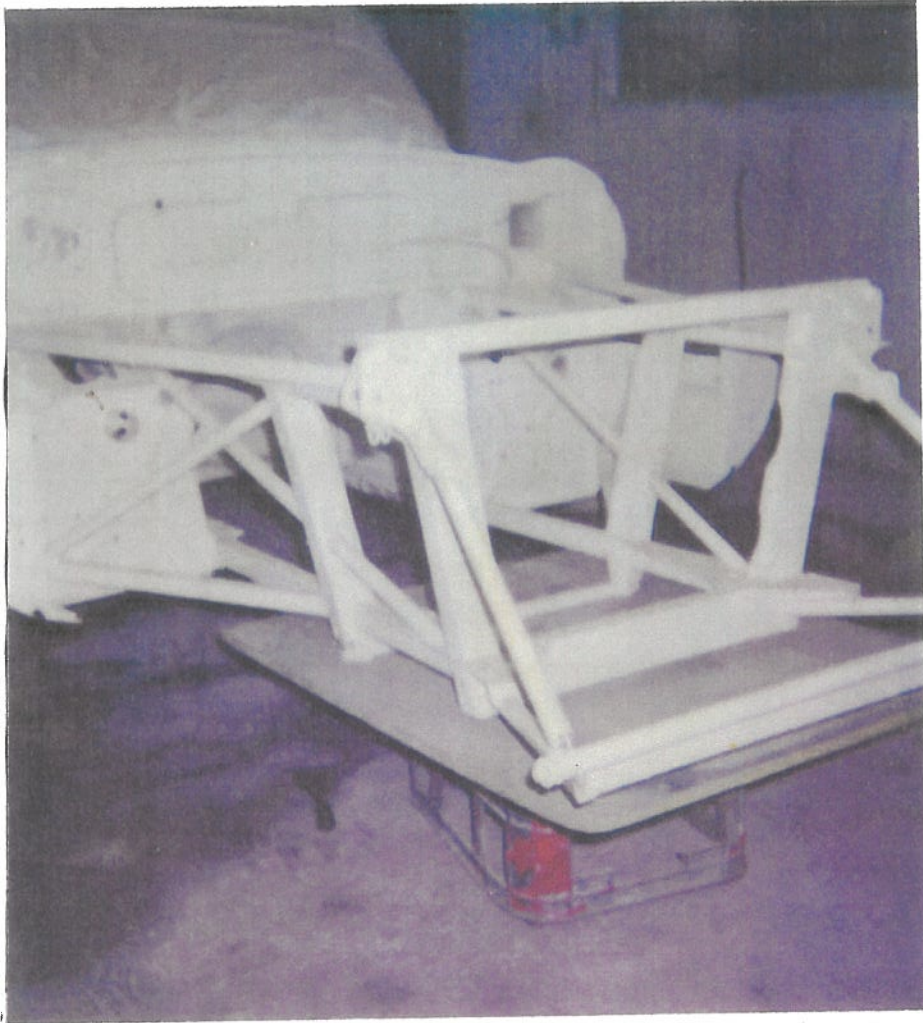
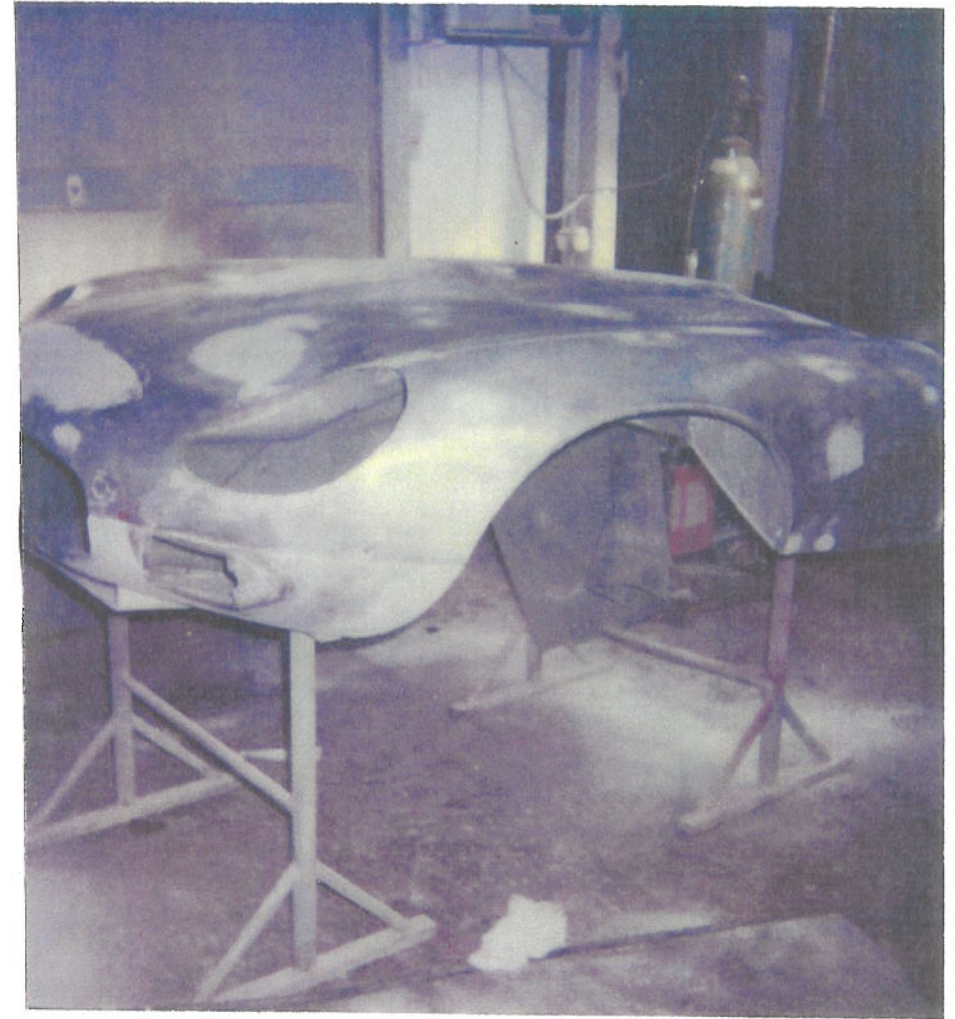
Photographs 11 and 12 – Chassi and bonnet undergoing re-finishing

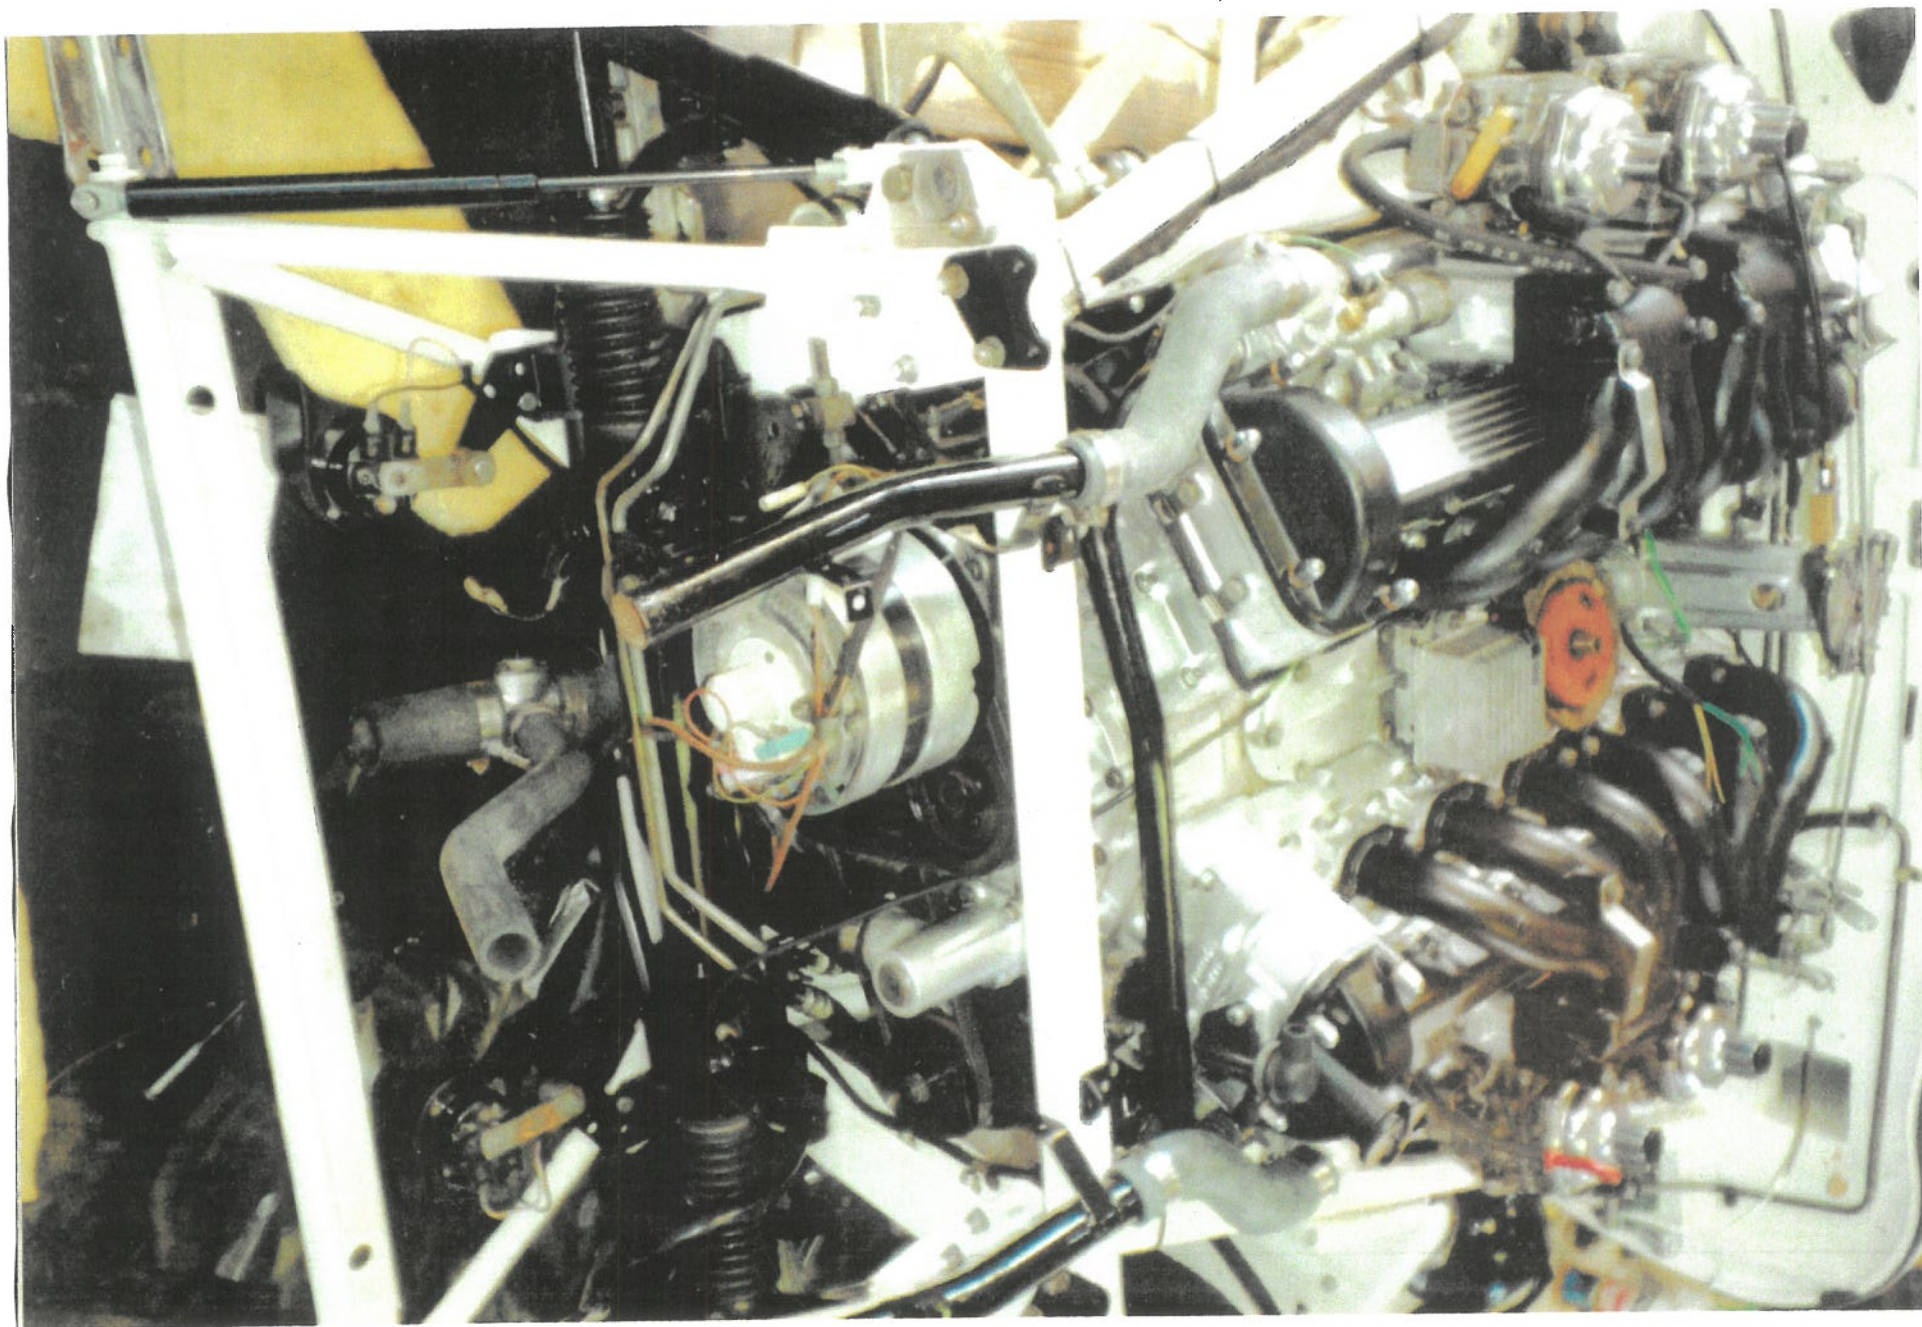
Photograph 13 – New ancillaries being fitted

*The engine was similarly stripped down including carburettors and ancillary equipment by John Master's Motor Engineers for complete checking, who certified at least a further 40,000 miles of engine life before any major work would be required. Notwithstanding, the owner had the engine rebored, with obvious piston replacement. The remainder of the engine, typically the heads, valve gear etc including ancillaries was fully reconditioned, in all £15,000 was spent on the engine, auto box, back axle, and ancillary reconditioning or replacement – wherever possible with original equipment (Refer Photographs 13 and 14).*

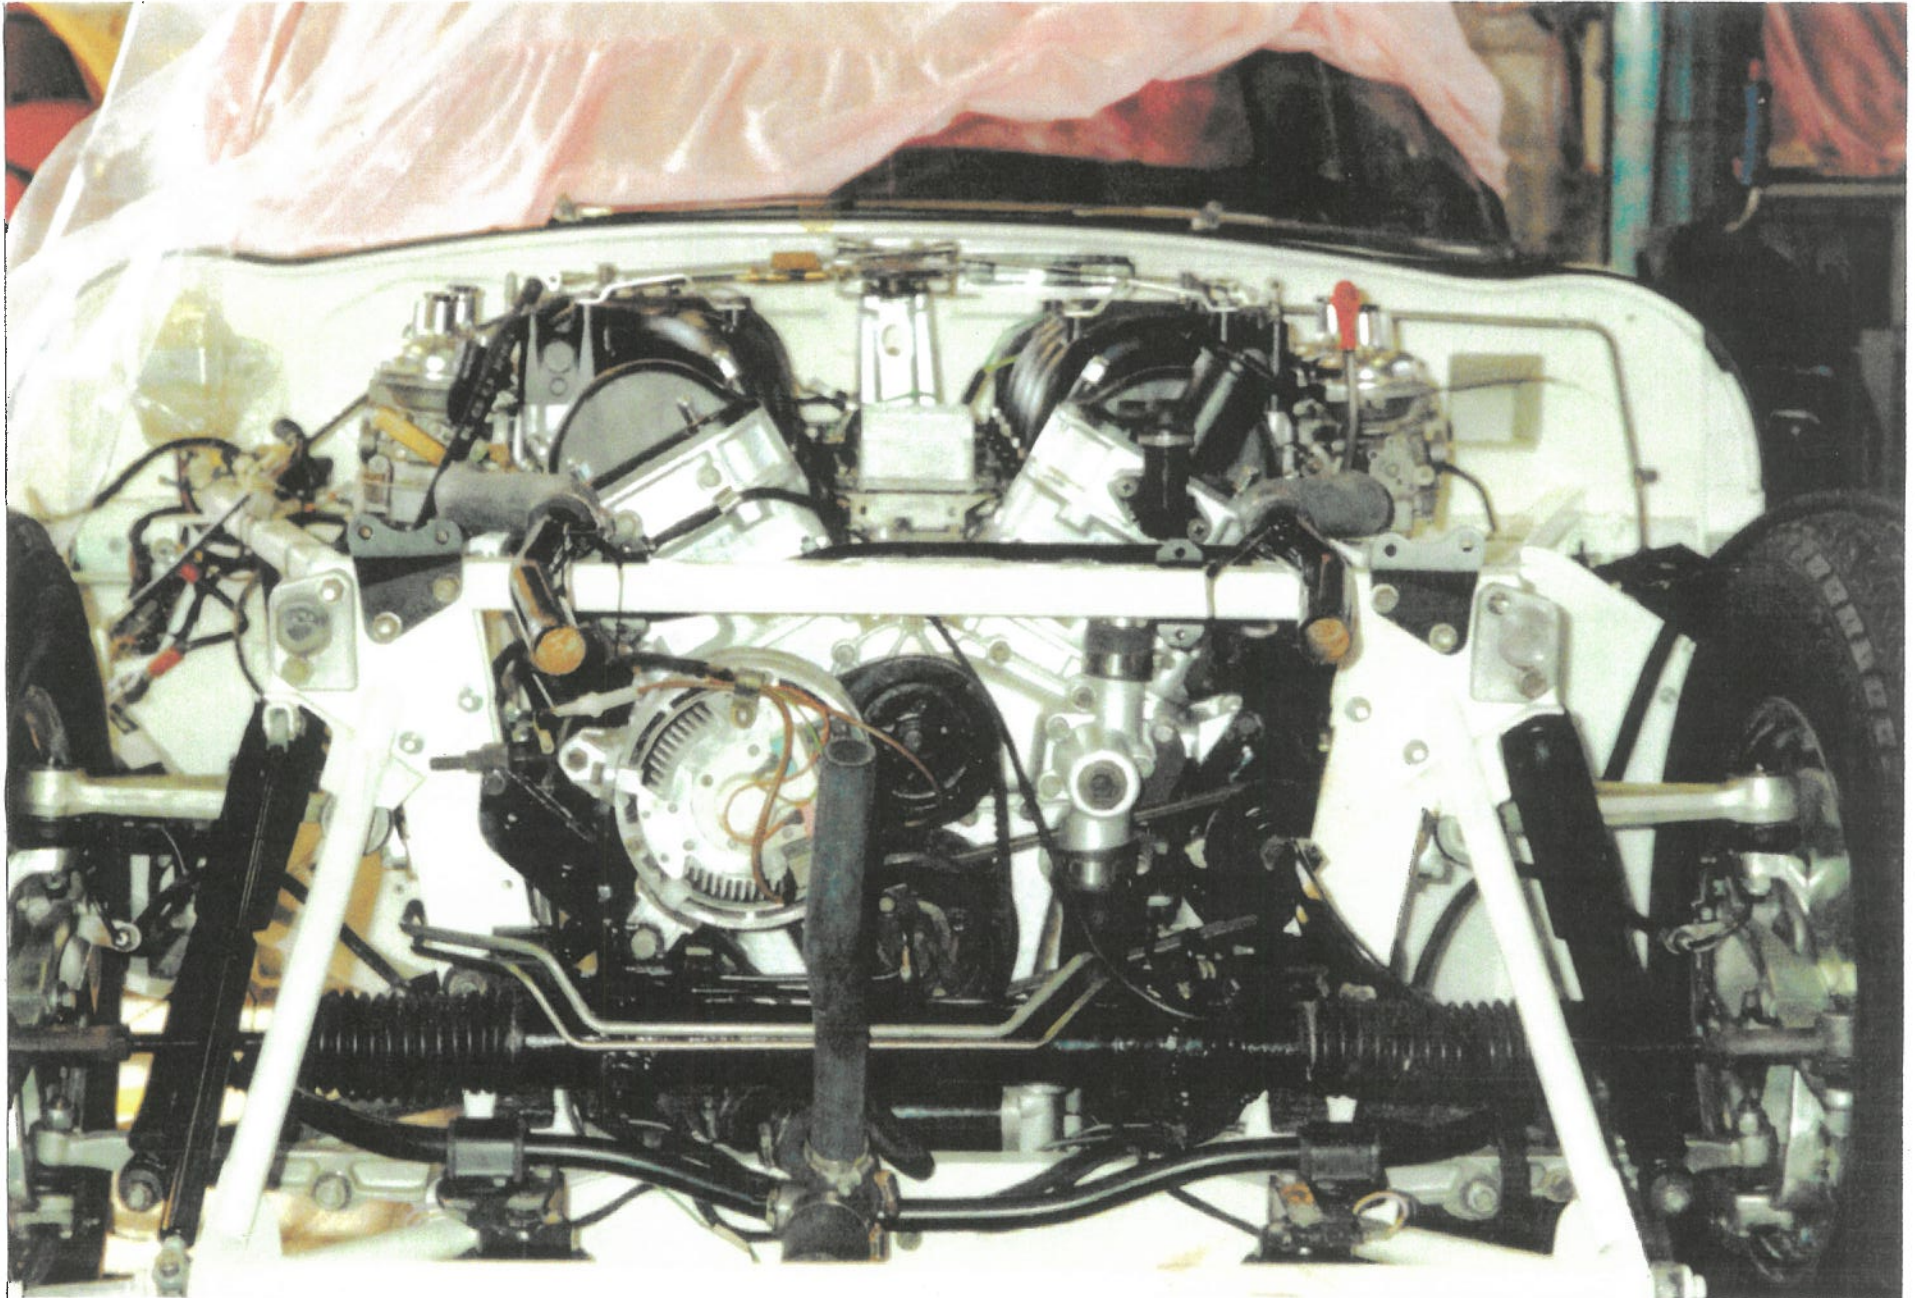
Photograph 14 – New ancillaries being fitted

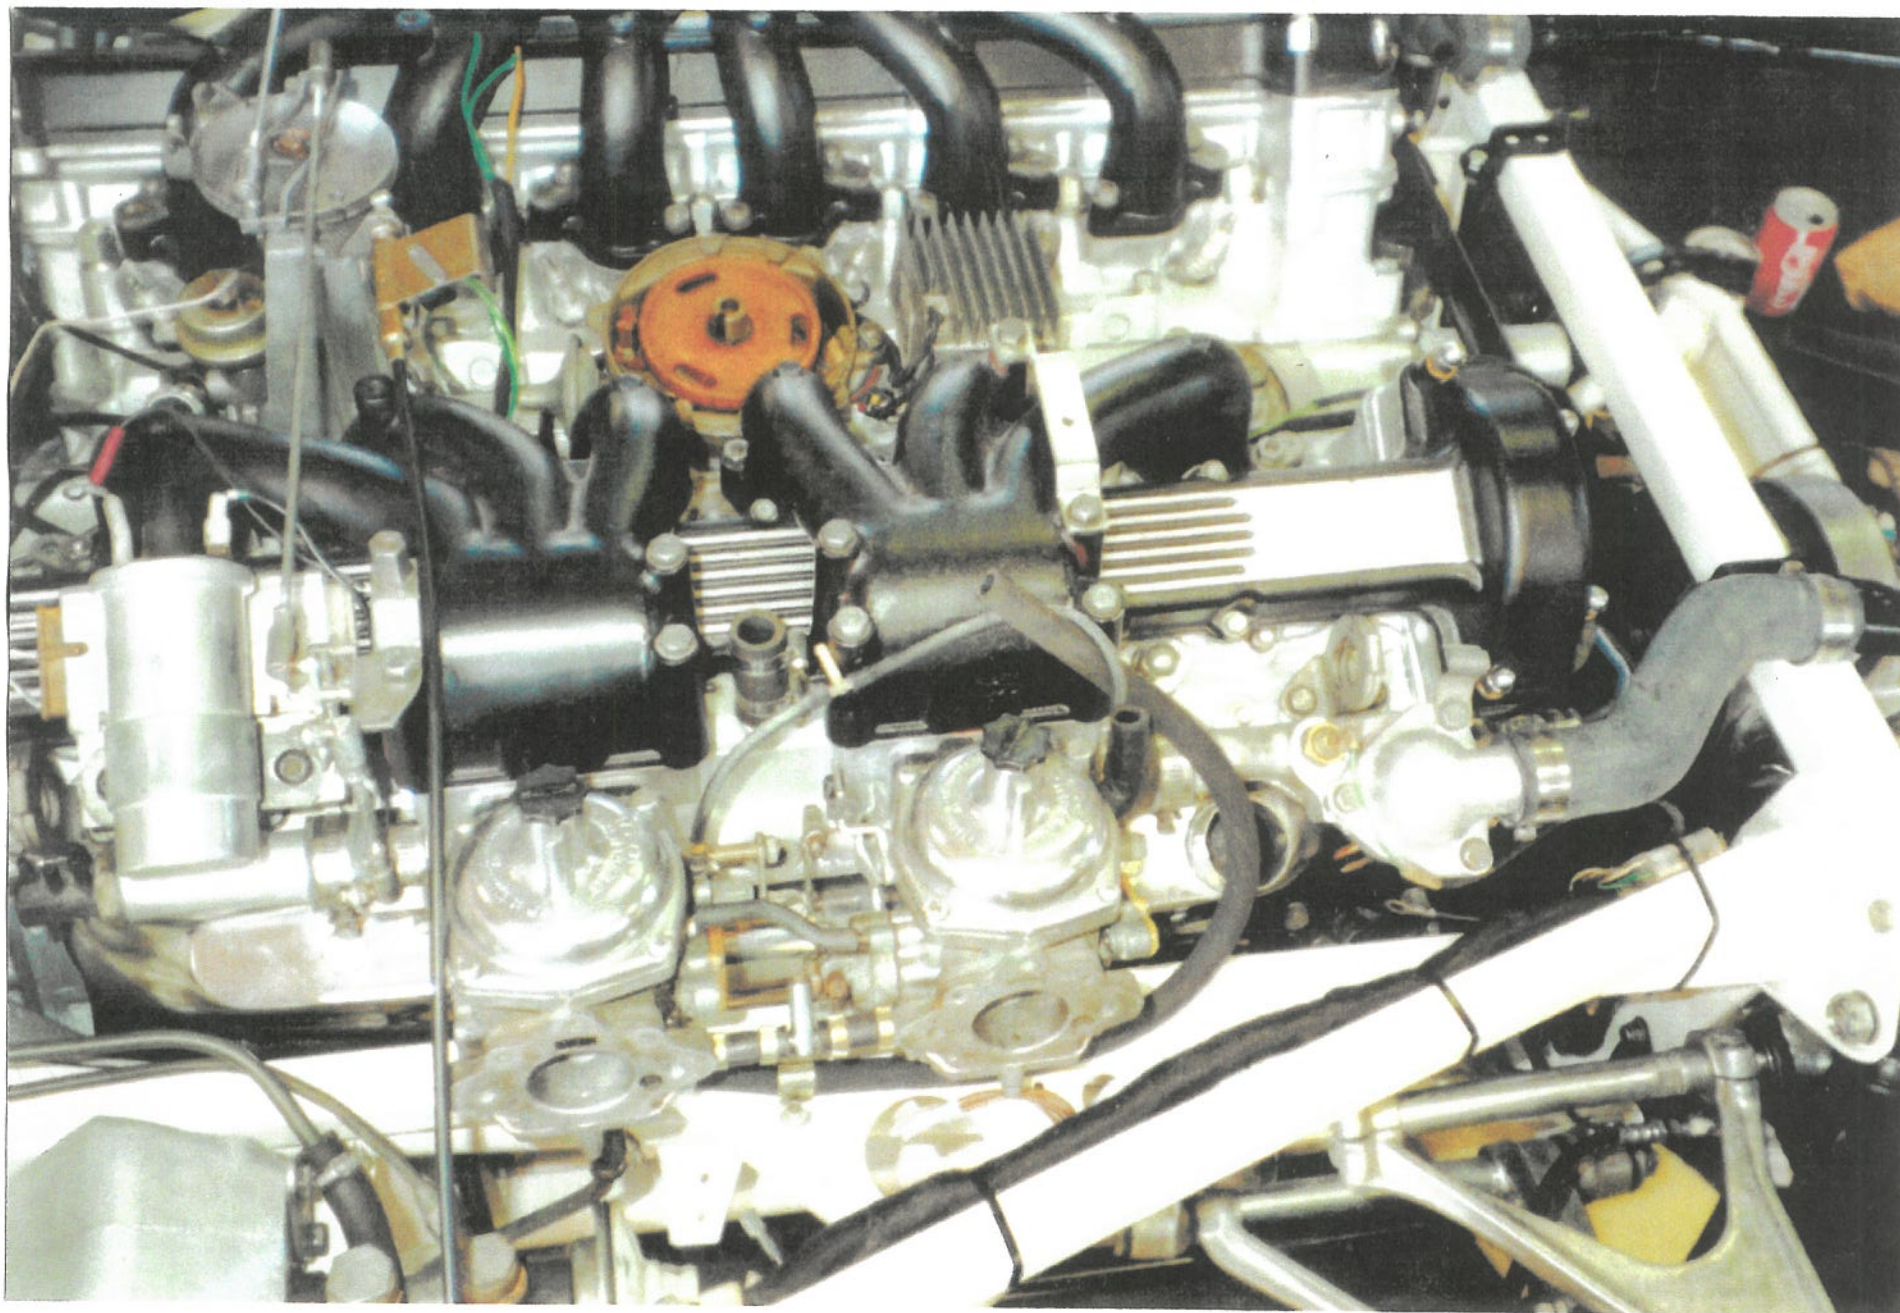
Photograph 15 – New hoses, petrol pipes and cable loom completed

- 1) *Radiator.*
- 2) *Header tank.*
- 3) *Water hoses.*
- 4) *Petrol pipes.*
- 5) *Battery.*
- 6) *Heater plenum.*
- 7) *Heater collection boxes.*
- 8) *Air cleaner box.*
- 9) *Air inlet ram-pipes.*

*(Refer Photographs 15 and 16)*

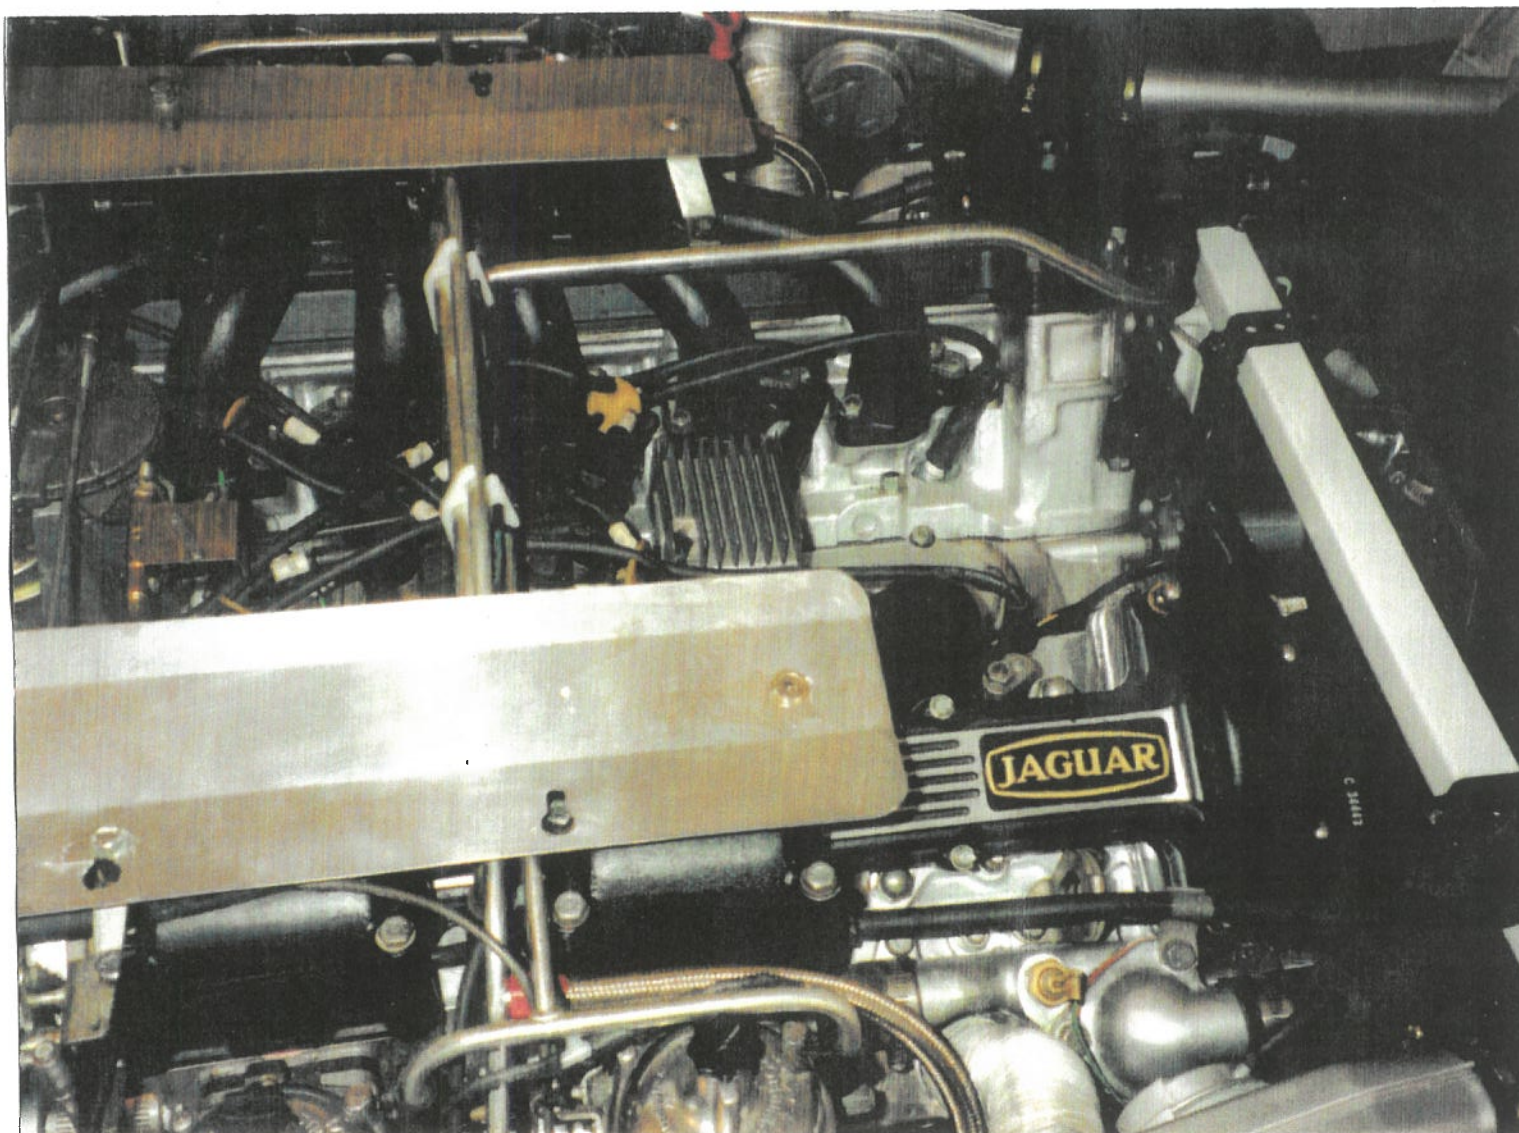
Photograph 16 – Replacement items, rad, fans etc almost complete

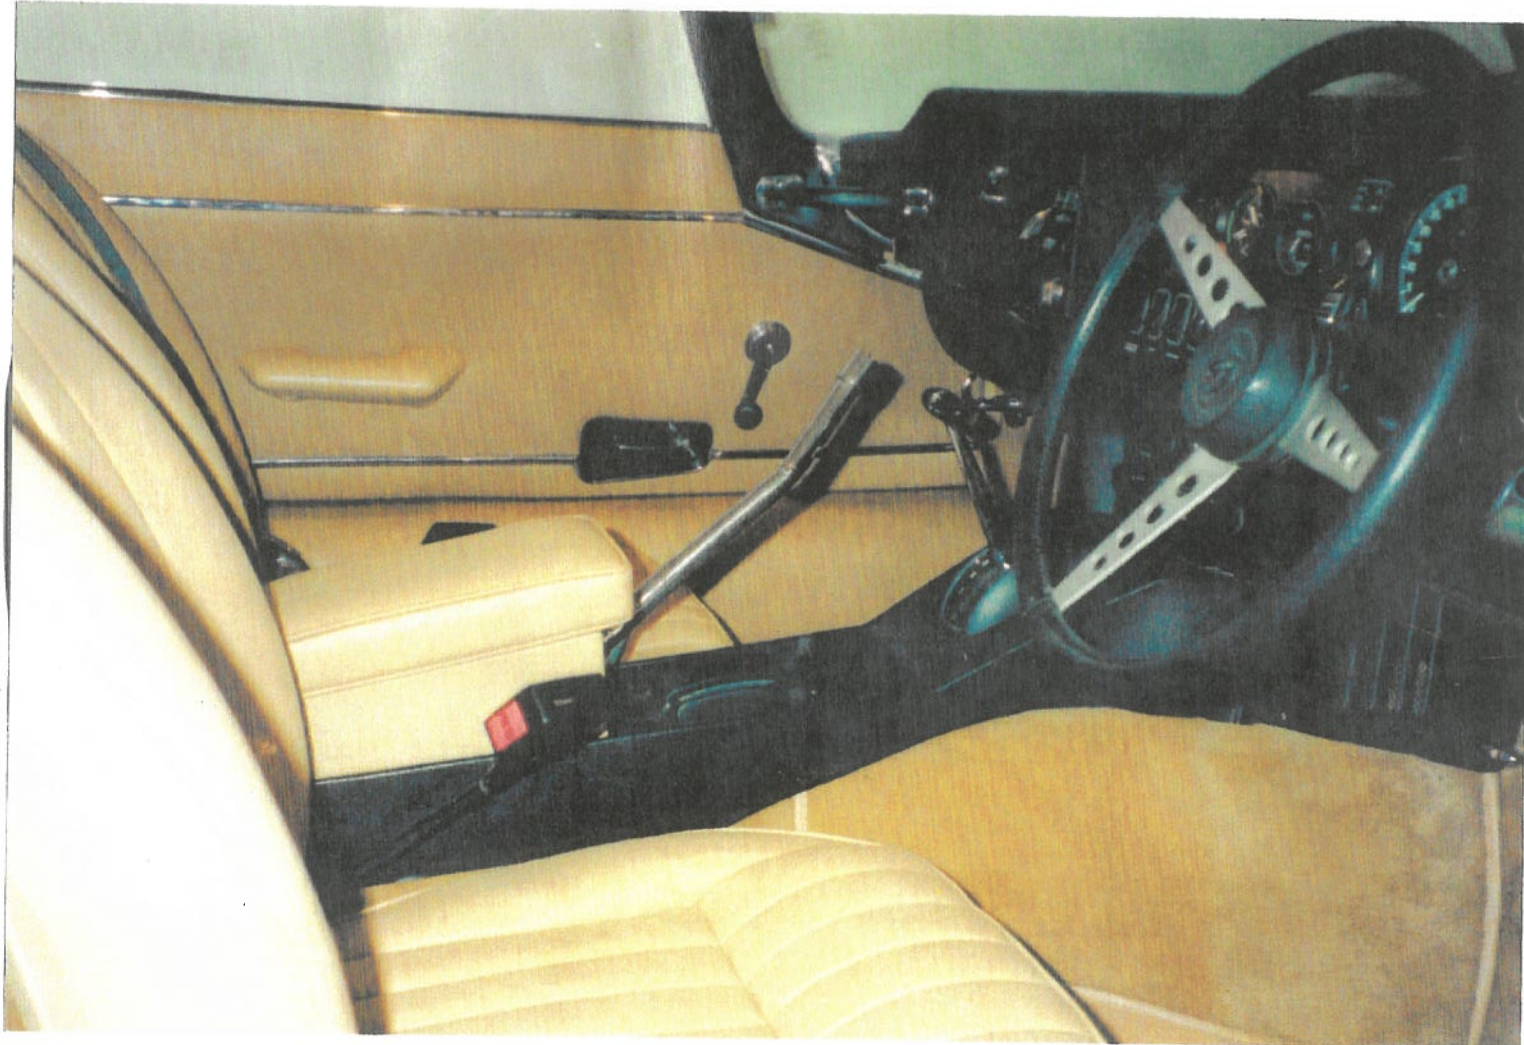
Photograph 17 – Interior completely re-furbished

*For interior refurbishment the car was passed to the Coventry firm of Kennilworth who replaced all interior trim, carpets and seats, only interior mechanical items were not replaced,*

*namely winders, handles, hood frame, seat adjusters etc, at a cost of £2,300 (Refer Photograph 17).*

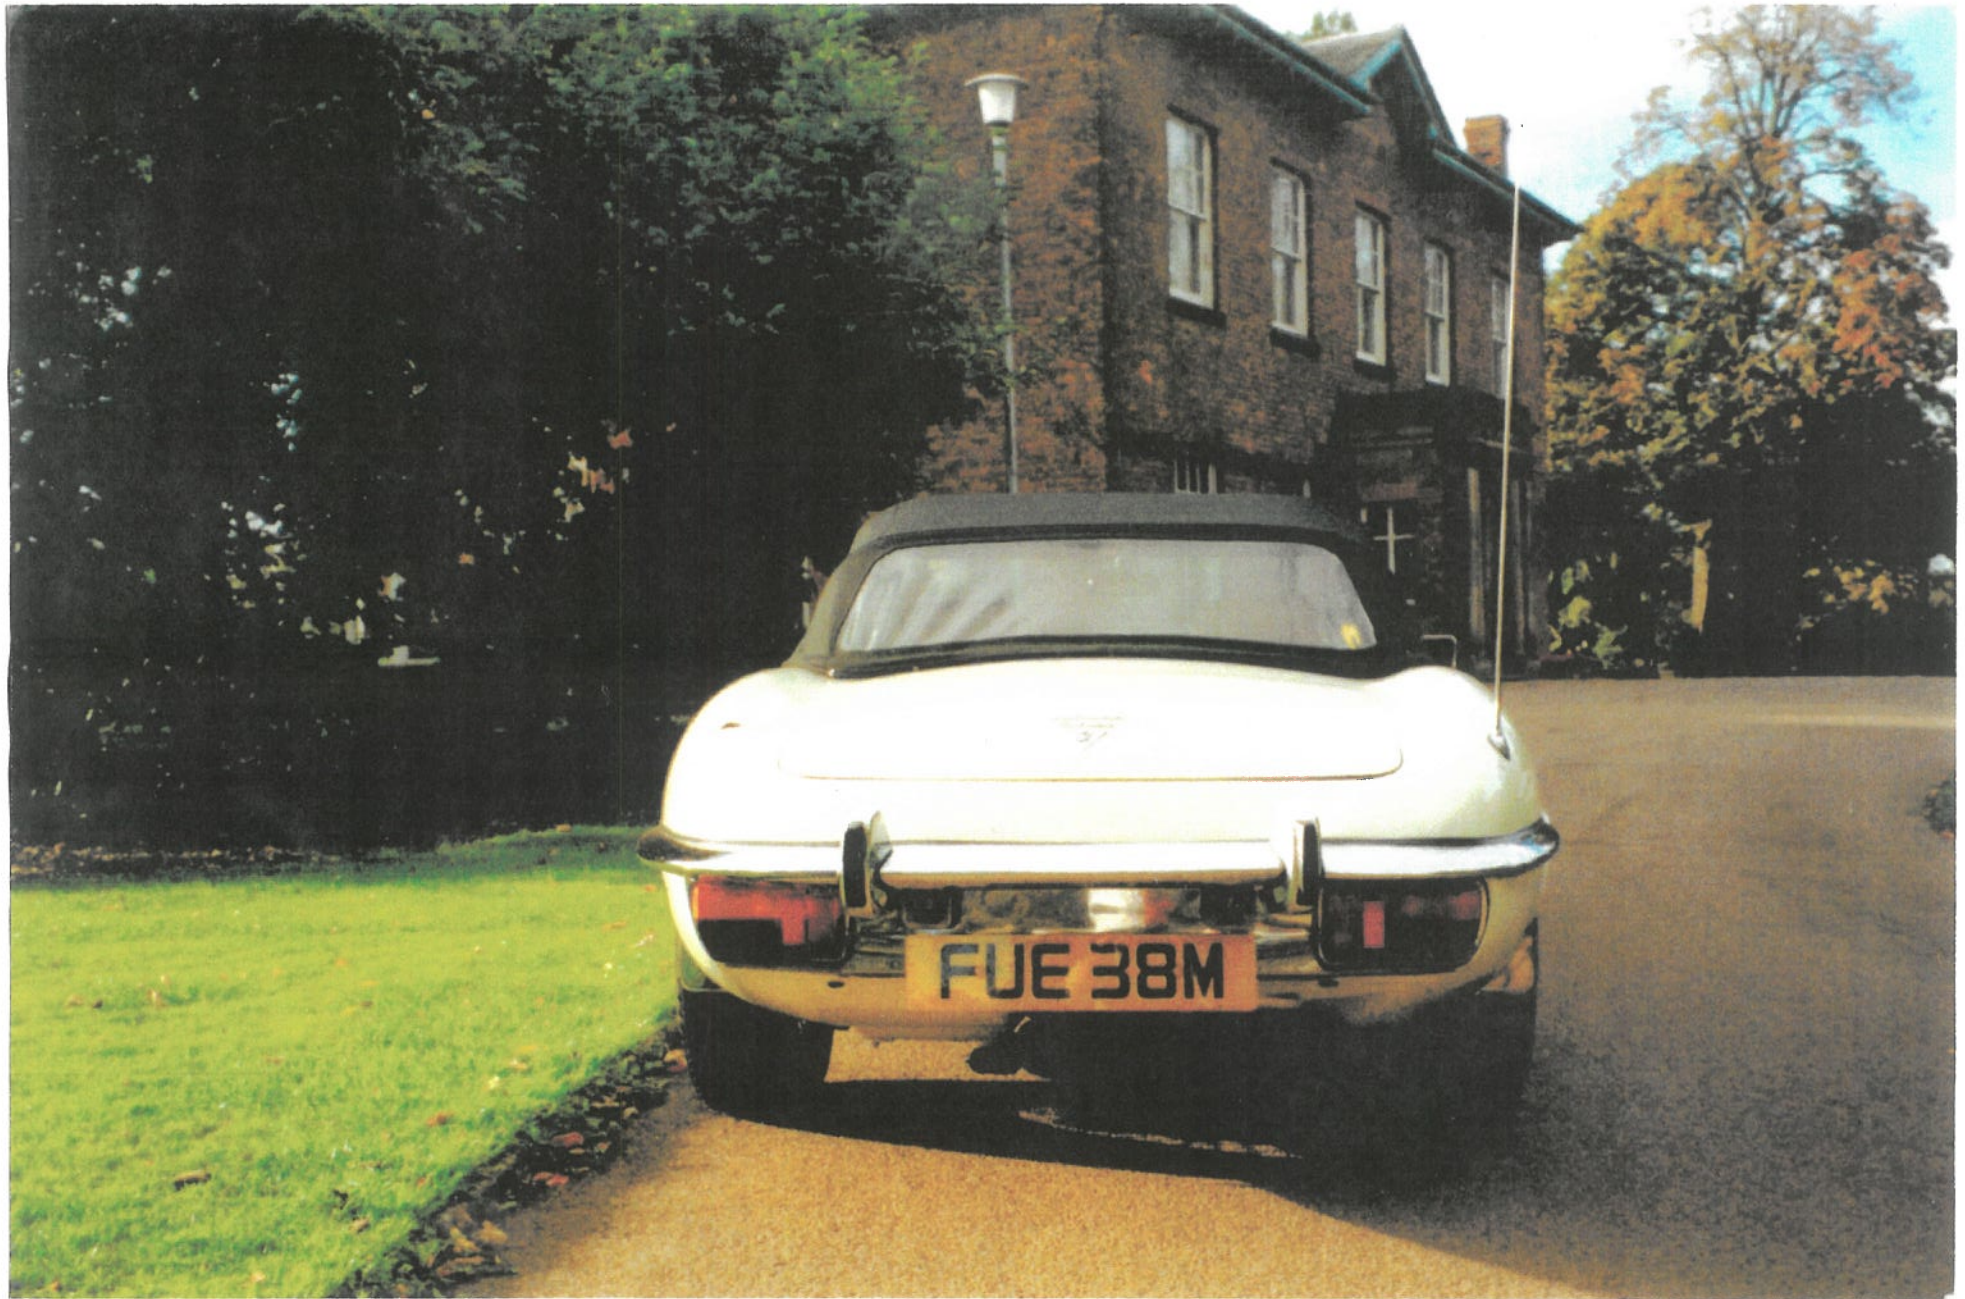
Photograph 18 – The car fully restored

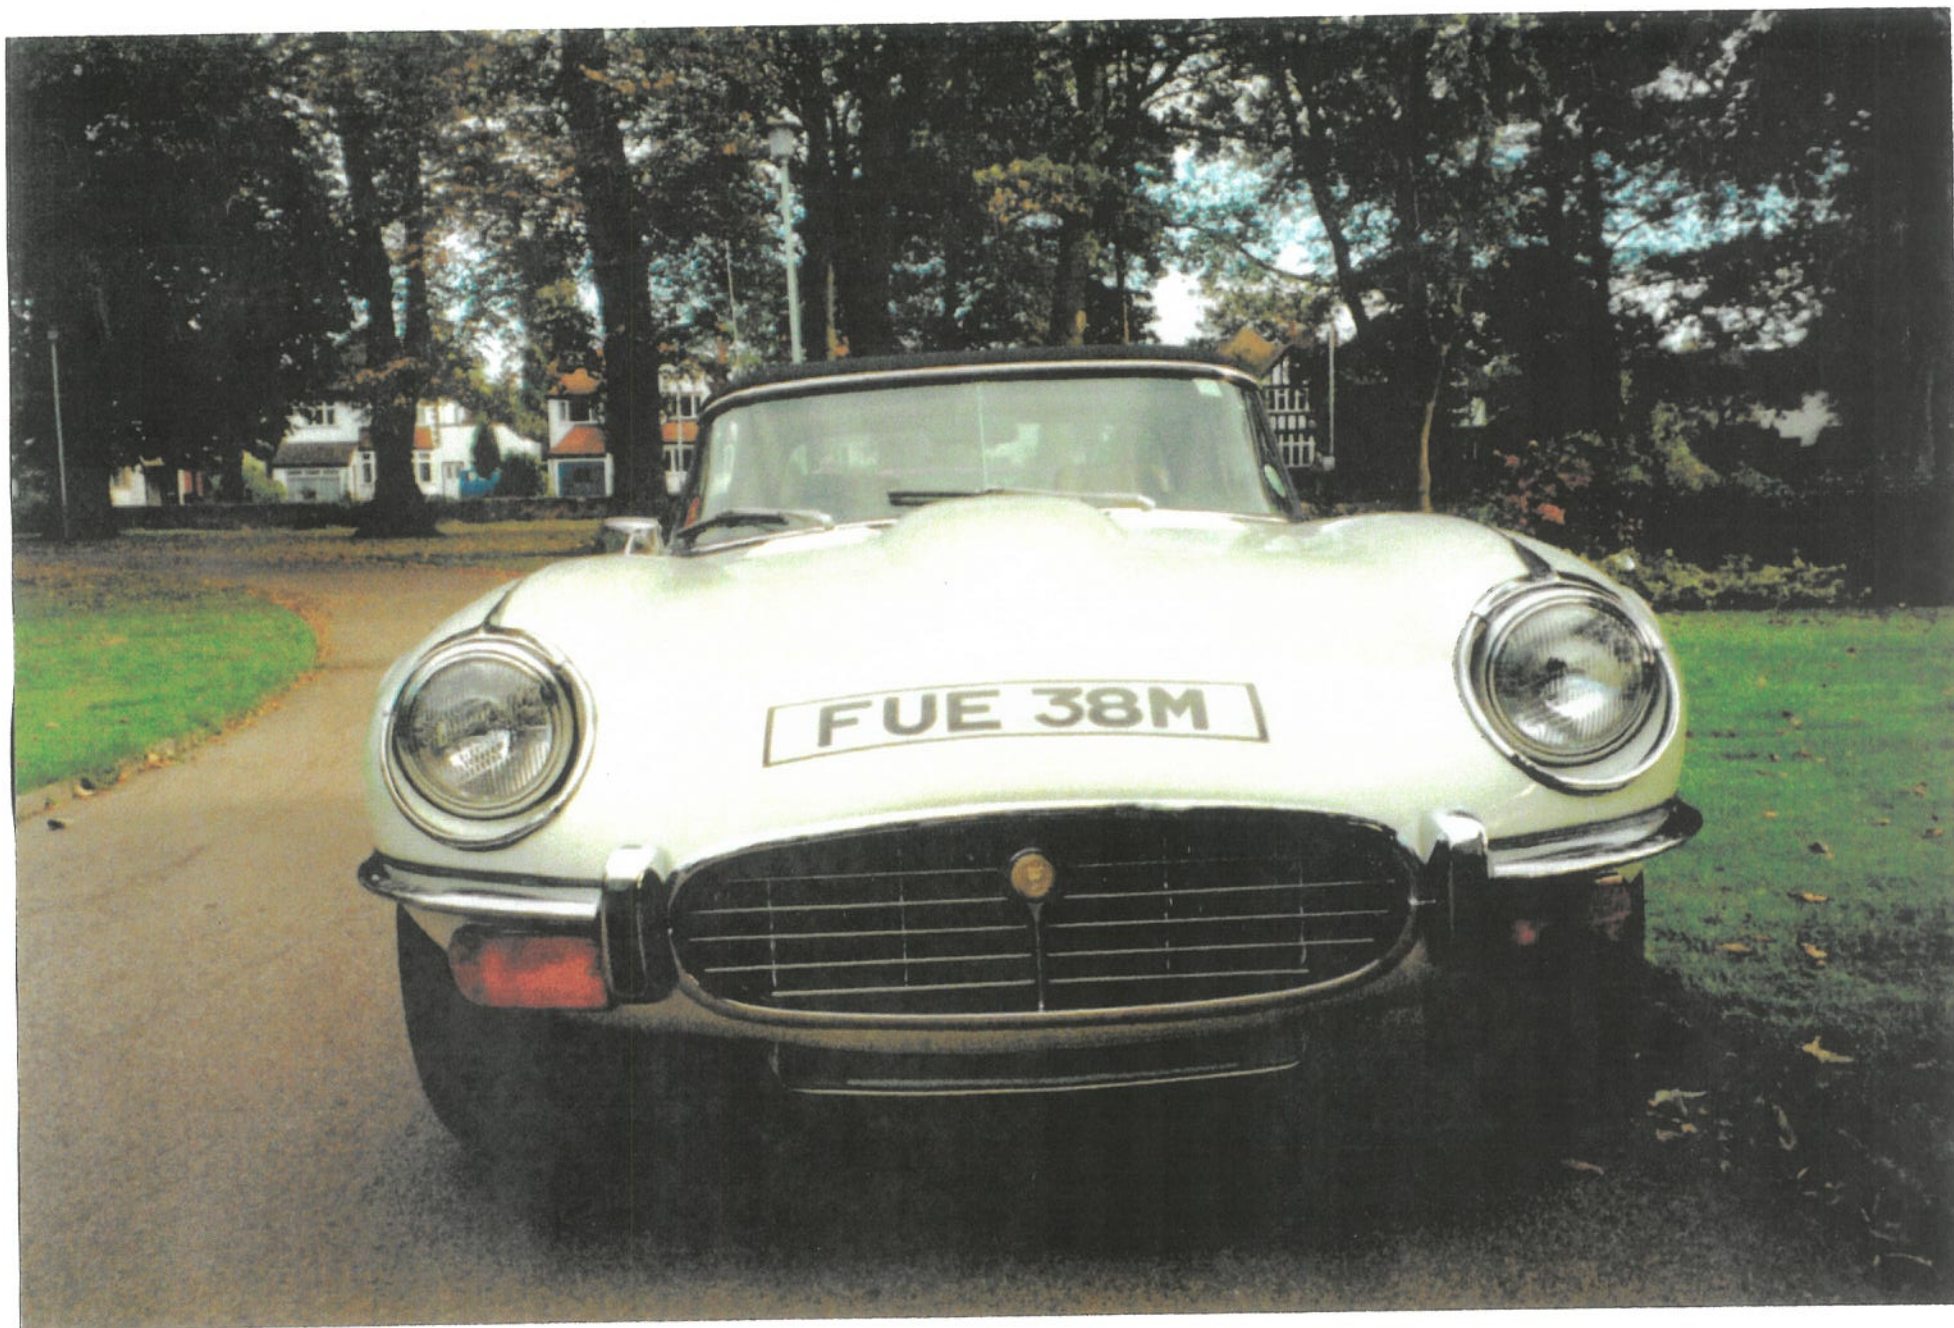
Photograph 19 – The car fully restored (Note damage on grill surround)
