***In compiling this short history on car number:-***

***UE 1S 25926 BW (Reg No FUE 38M)***

*The Jaguar E Type Series III V12 Roadster, body number 4S 8745 now registered FUE 38M was completed at the Jaguar Coventry Works on 9 May 1974. It was built to meet the American (Federal) car/road vehicle specification in force at that time.*

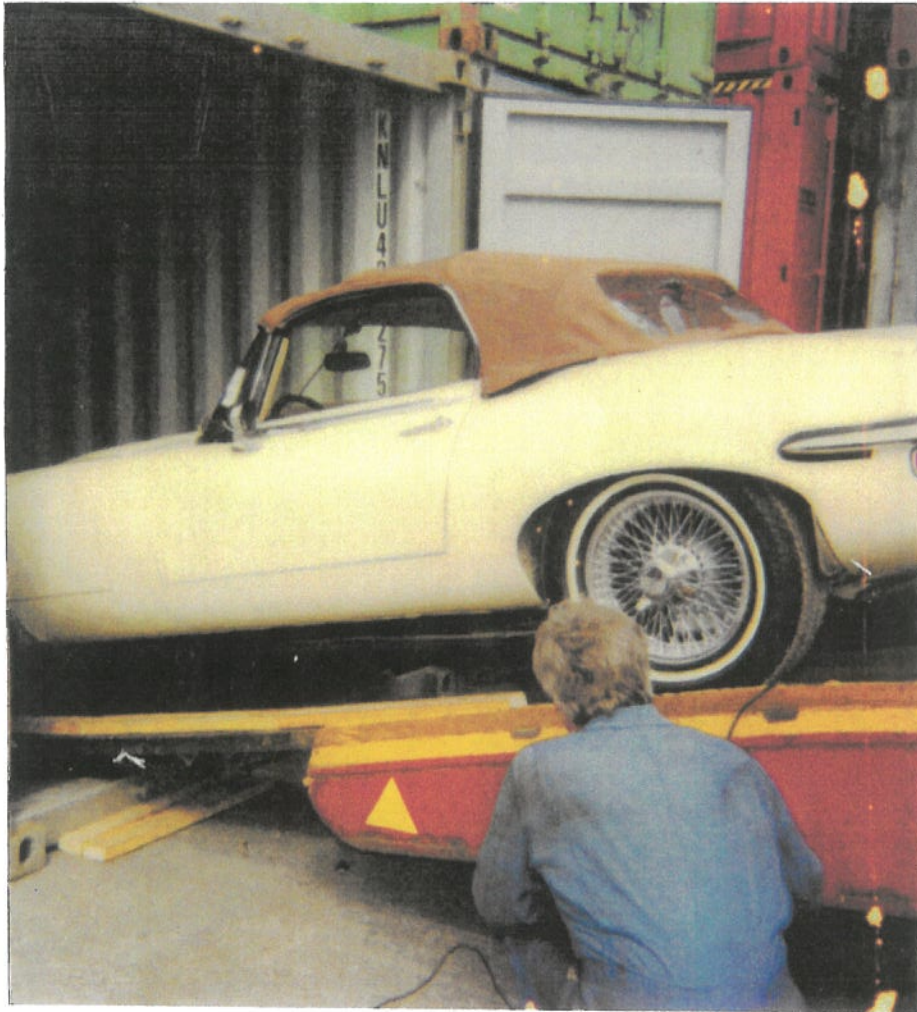
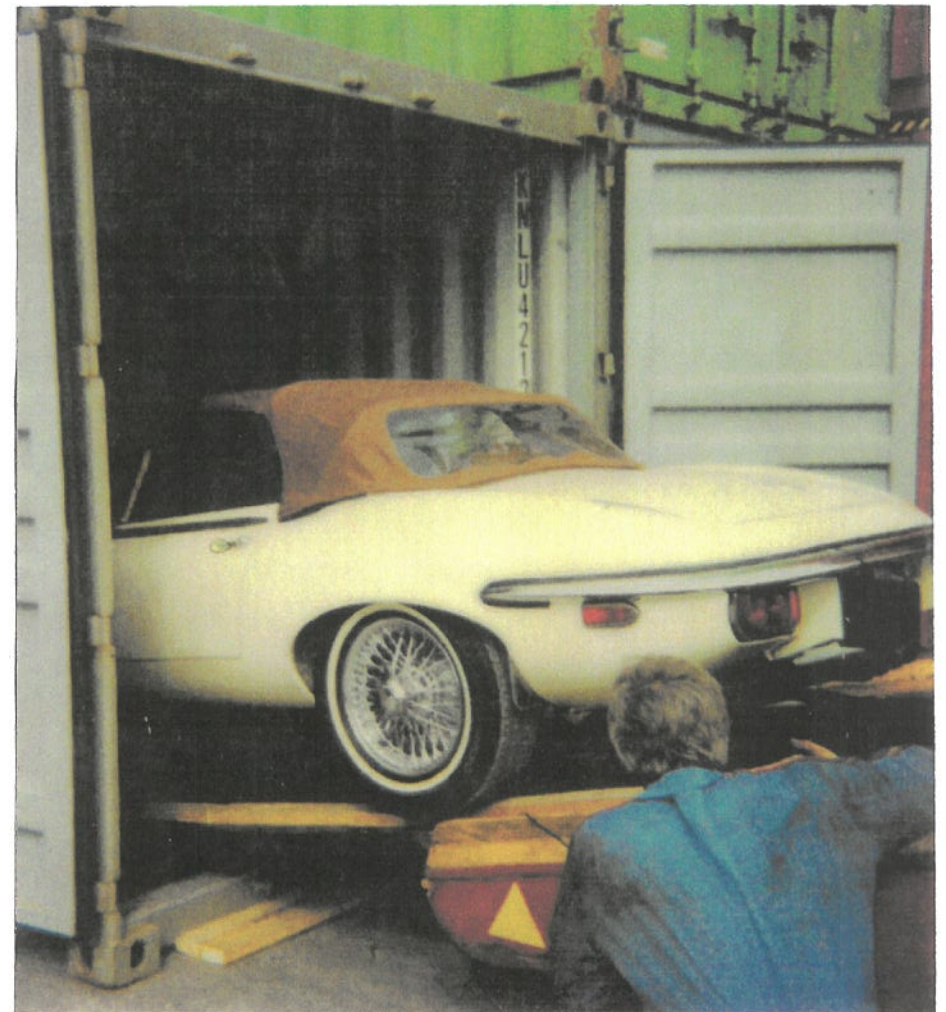
Photographs 5 and 6 – Container loading prior to shipping to England

*The car was container shipped in March 1990 (Refer Photographs 5 and 6) from Port Everglades, direct to Liverpool on the SS Holland, clearing customs in April 1990.*

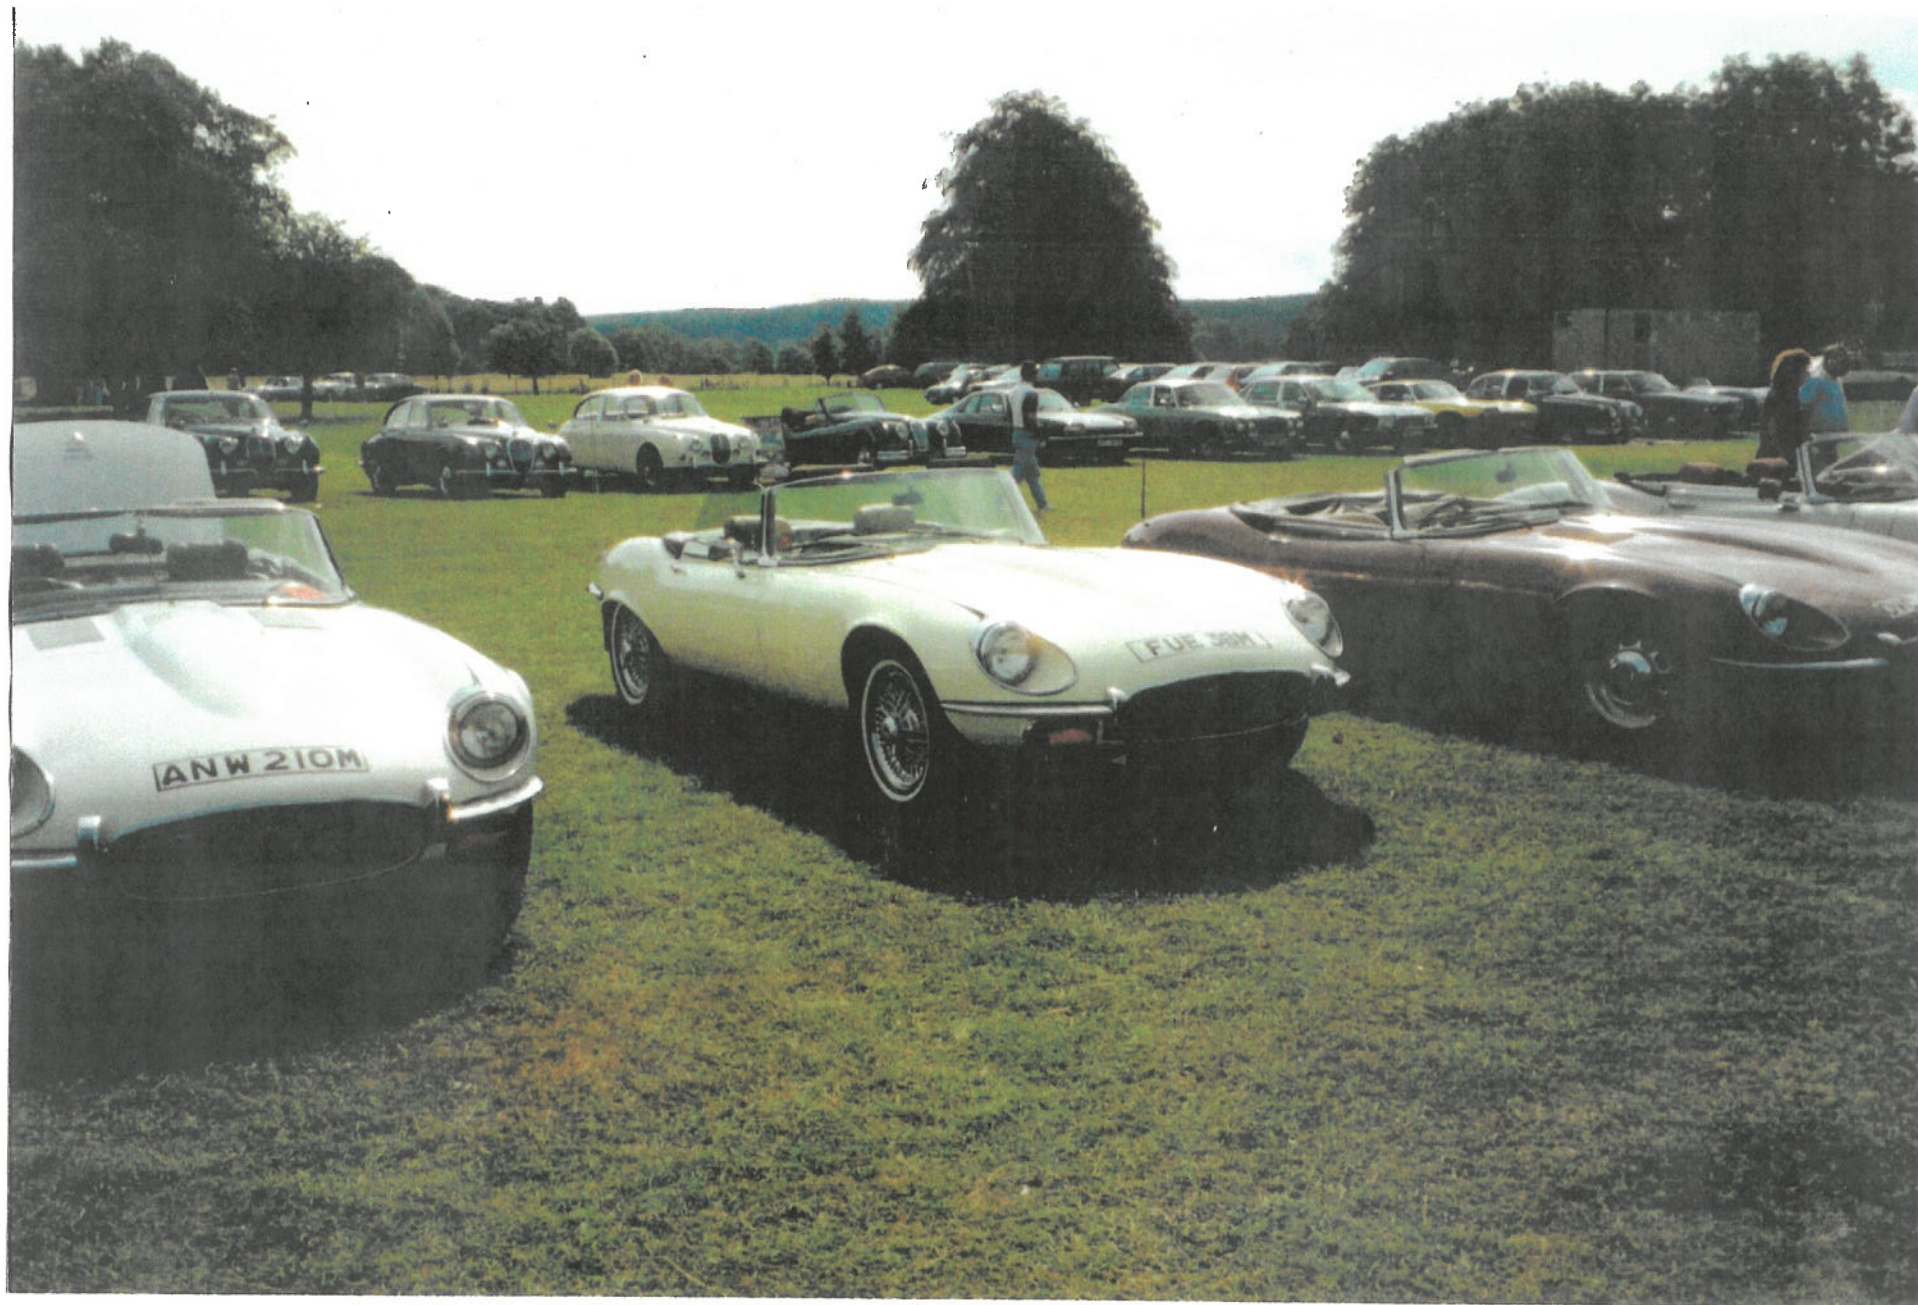
Photograph 20 – Exhibiting at shows like this one

***After restoration (Refer Photographs 18 and 19) the car was little used, covering less than 800 miles between 1990/91 and 1997, mainly used for special club events and attending Jaguar car show functions (Refer Photograph 20).***
